1
2
3
4
5
6
7
8 UNITED STATES DISTRICT COURT
9 NORTHERN DISTRICT OF CALIFORNIA
10 SAN FRANCISCO DIVISION

11 IN RE SEAGATE TECHNOLOGY LLC
12 LITIGATION

13 DECLARATION OF ANDREW
14 HOSPODOR IN SUPPORT OF
15 PLAINTIFFS' MOTION FOR CLASS
16 CERTIFICATION

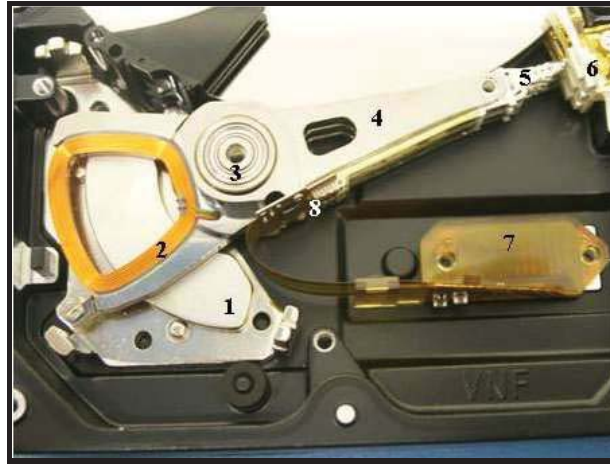
Figure 22: An example of a Head Stack Assembly.⁵⁶

145. On August 3, 2011, ECR0138496 was raised to allow for “Initial Release & Structure of NHK 4.5 HSAs.” The HSA is the Head Stack Assembly that contains the recording heads, positioning arm, and servo motor windings. A picture of a typical HSA is shown below:

146. The HSA is a major component of a HDD, so it was unusual to see a new HSA design being introduced to the Grenada product line only four months into mass production. In fact, the HSA must be a stable to mass produce reliable hard drives. Redesigning the HSA after the first quarter of production suggests the Drive was not ready for production with its original HSA. Many of the other mechanical ECRs are also related to either the HSA or HDA (Head Disk Assembly) areas.
